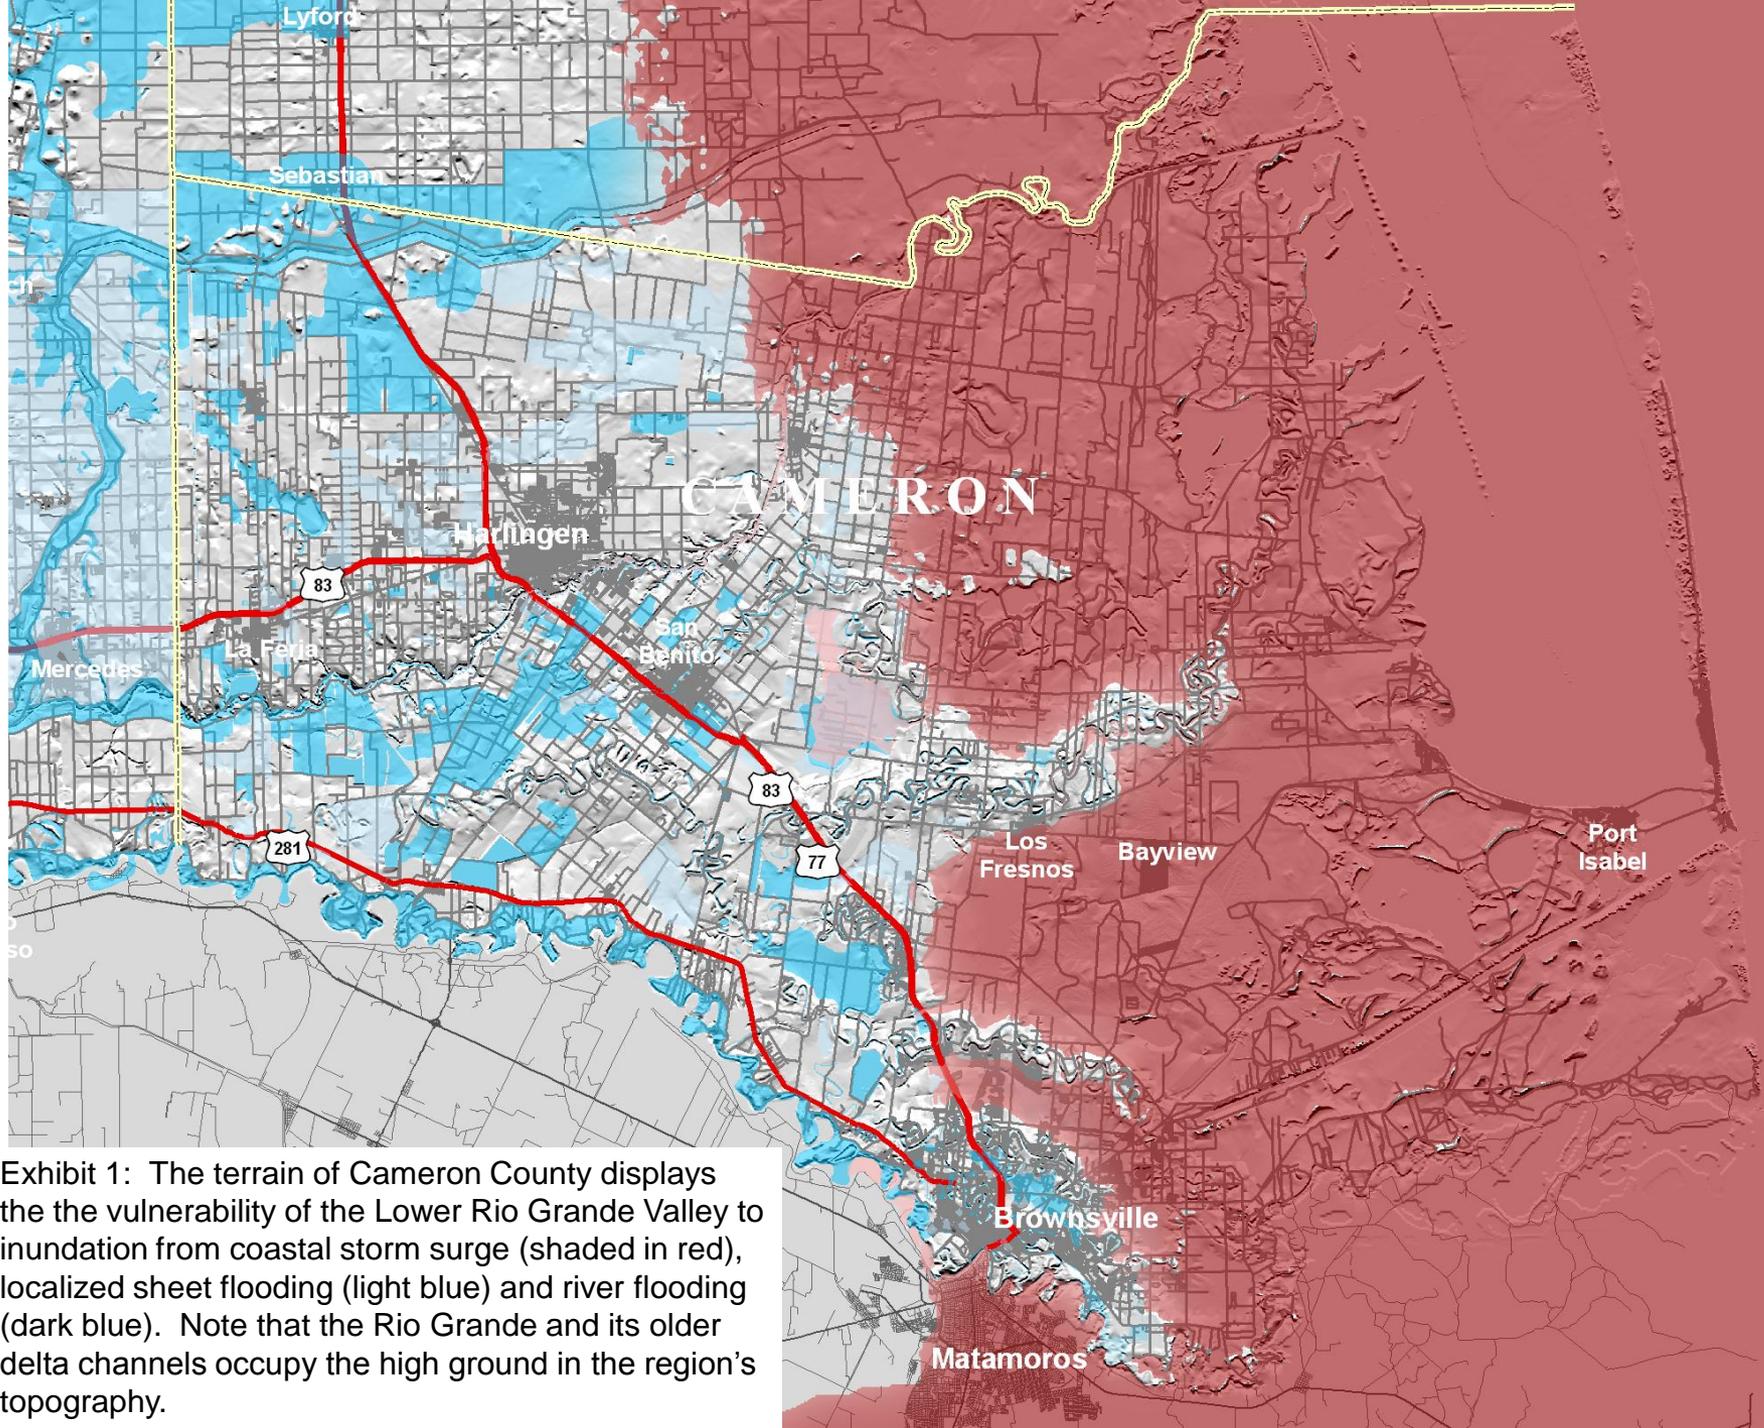
**LiDAR Elevation Image**

Exhibit 1: The terrain of Cameron County displays the the vulnerability of the Lower Rio Grande Valley to inundation from coastal storm surge (shaded in red), localized sheet flooding (light blue) and river flooding (dark blue). Note that the Rio Grande and its older delta channels occupy the high ground in the region's topography.

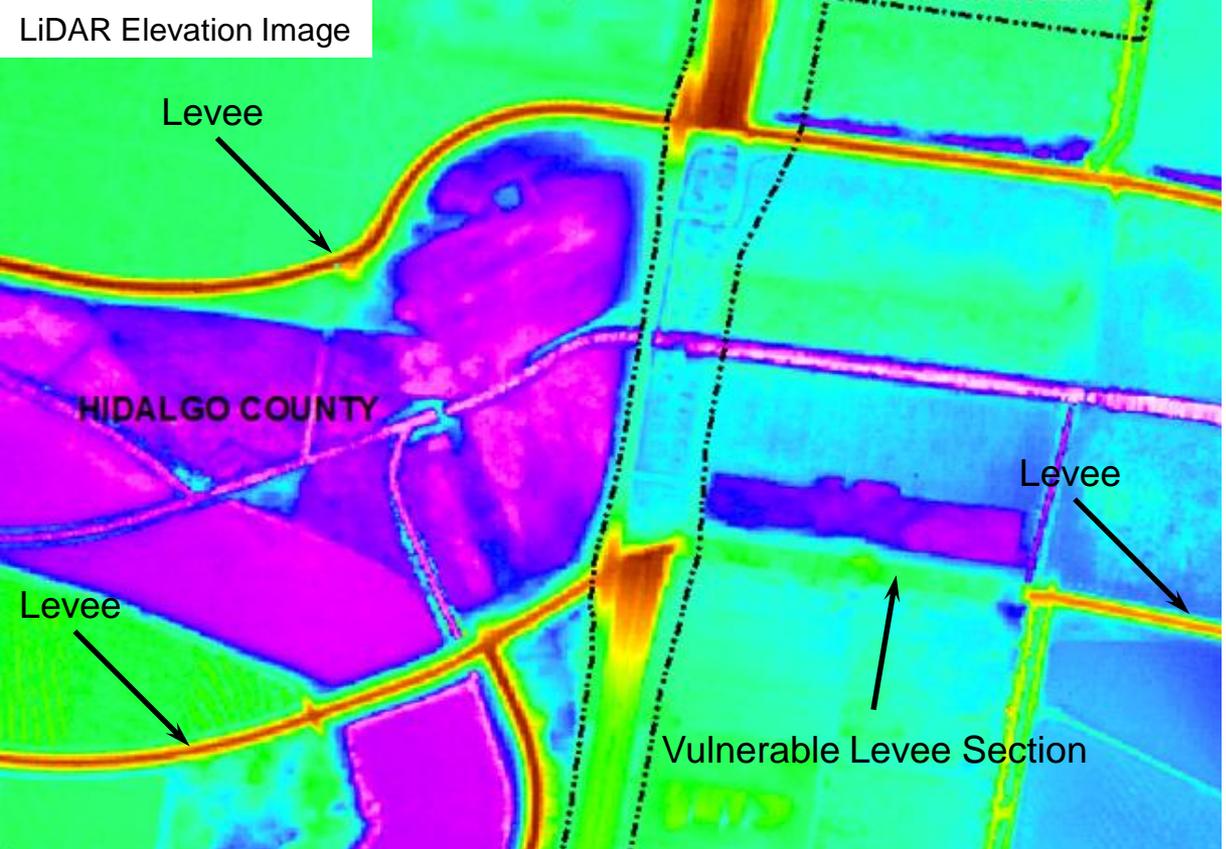
Exhibit 2: Recent repairs to the levees along the Main Floodway in Hidalgo County prevented serious flooding following the emergency release of floodwaters into the interior floodways of the Lower Rio Grande Flood Control Project in July 2010. Extremely accurate aerial laser terrain mapping surveys conducted in 2003-4 identified vulnerable levee sections (upper right LiDAR image). Aerial Photographs taken by the Texas Civil Air Patrol on July 6 and July 20 (bottom left and right) show the successfully repaired levee section located north of the City of Hidalgo before and after floodwaters entered the Main Floodway. Local bonds funded the acceleration of levee repairs in the region. Without such repairs, widespread damage would have occurred to areas near the interior floodway and primary levee along the Rio Grande.

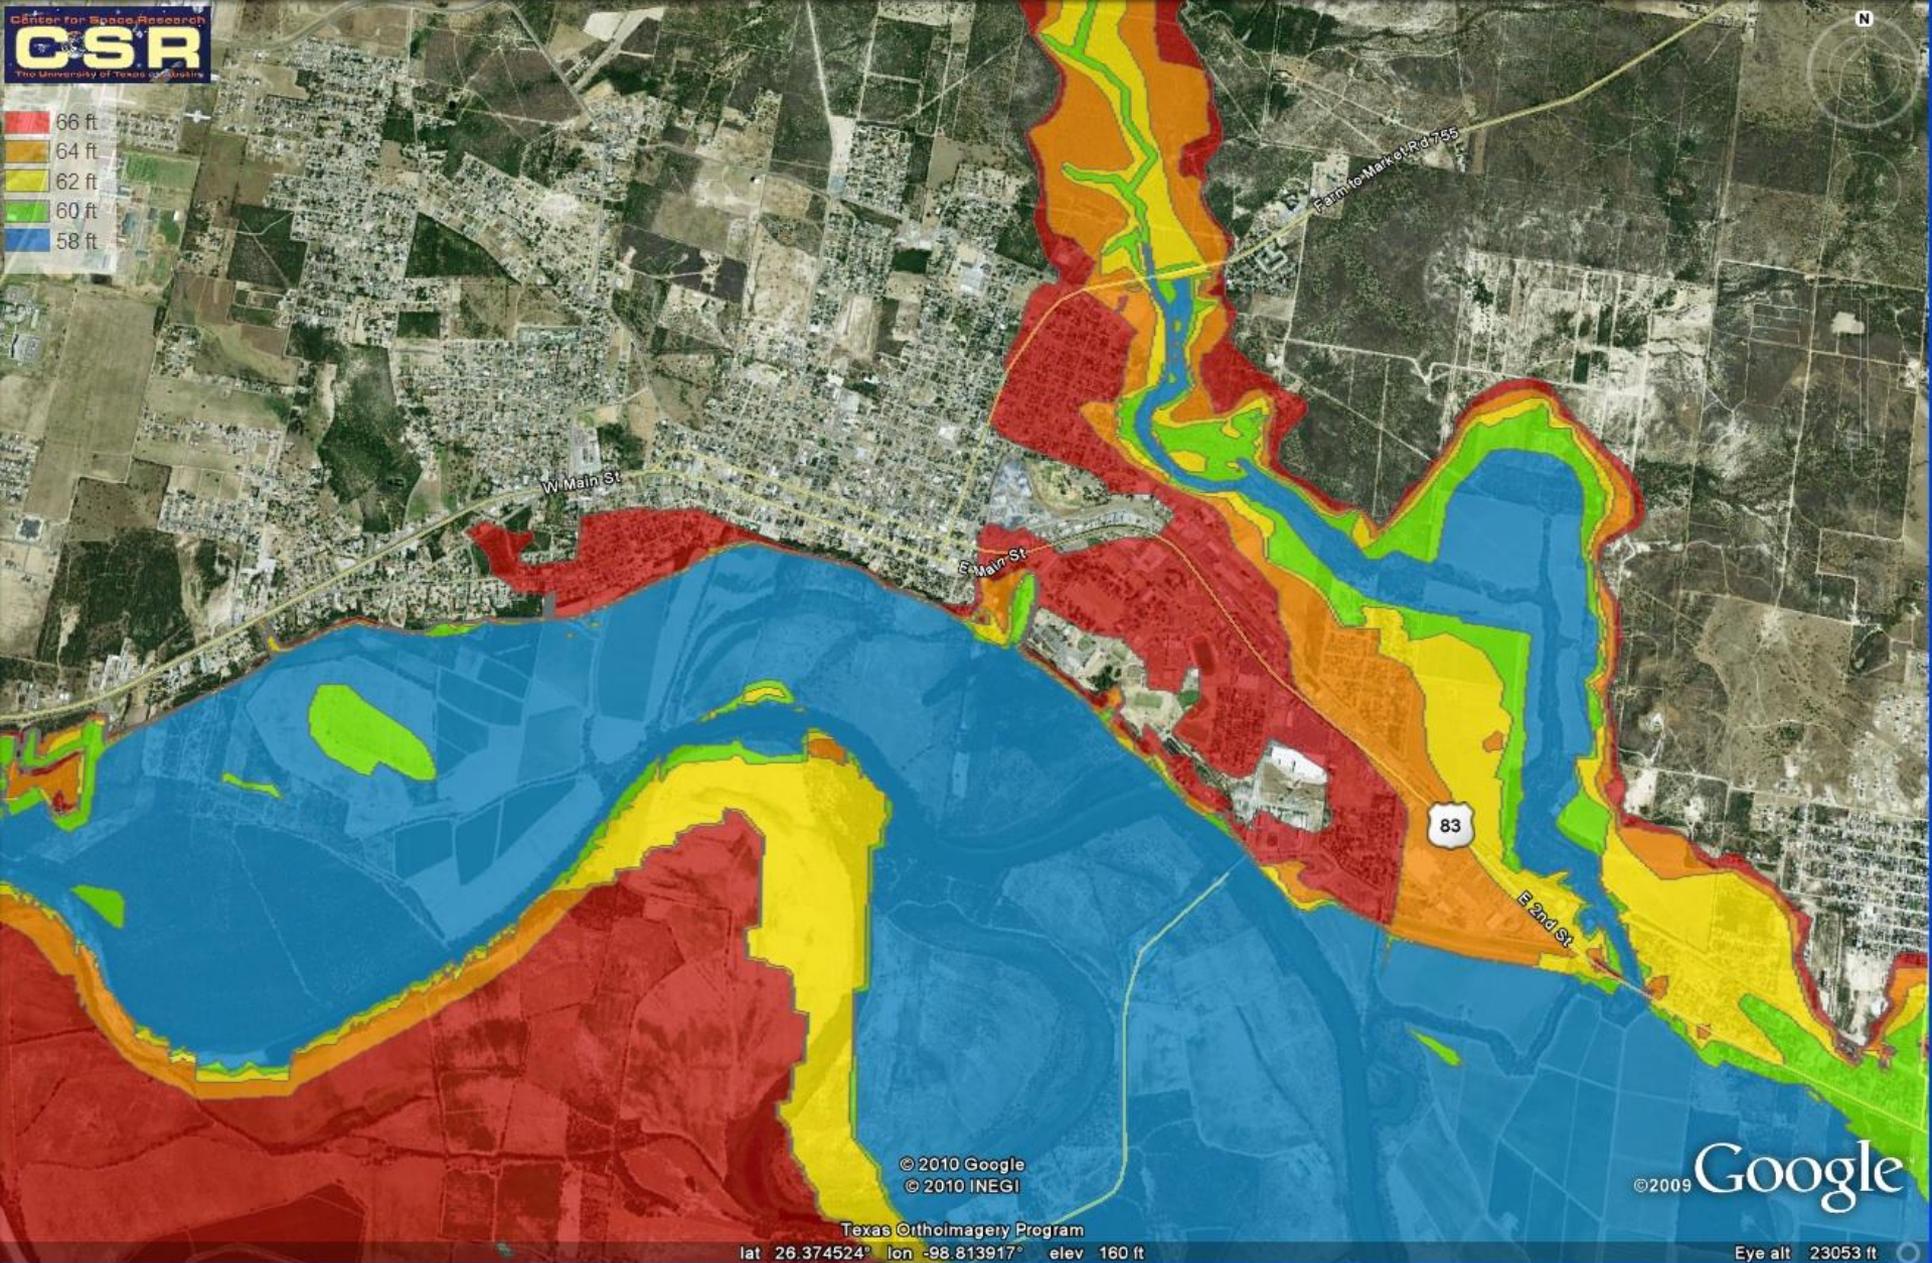
Exhibit 3: An inundation map of Rio Grande City correlates with river stage heights as calculated by the West Gulf River Forecast Center. Stage heights range from 58 feet to 66 feet. Major flooding in Rio Grande City results largely from backflow along Los Olmos Creek, which inundates the unprotected eastern portion of town. These model results can be distributed as a KMZ file for viewing in Google Earth.

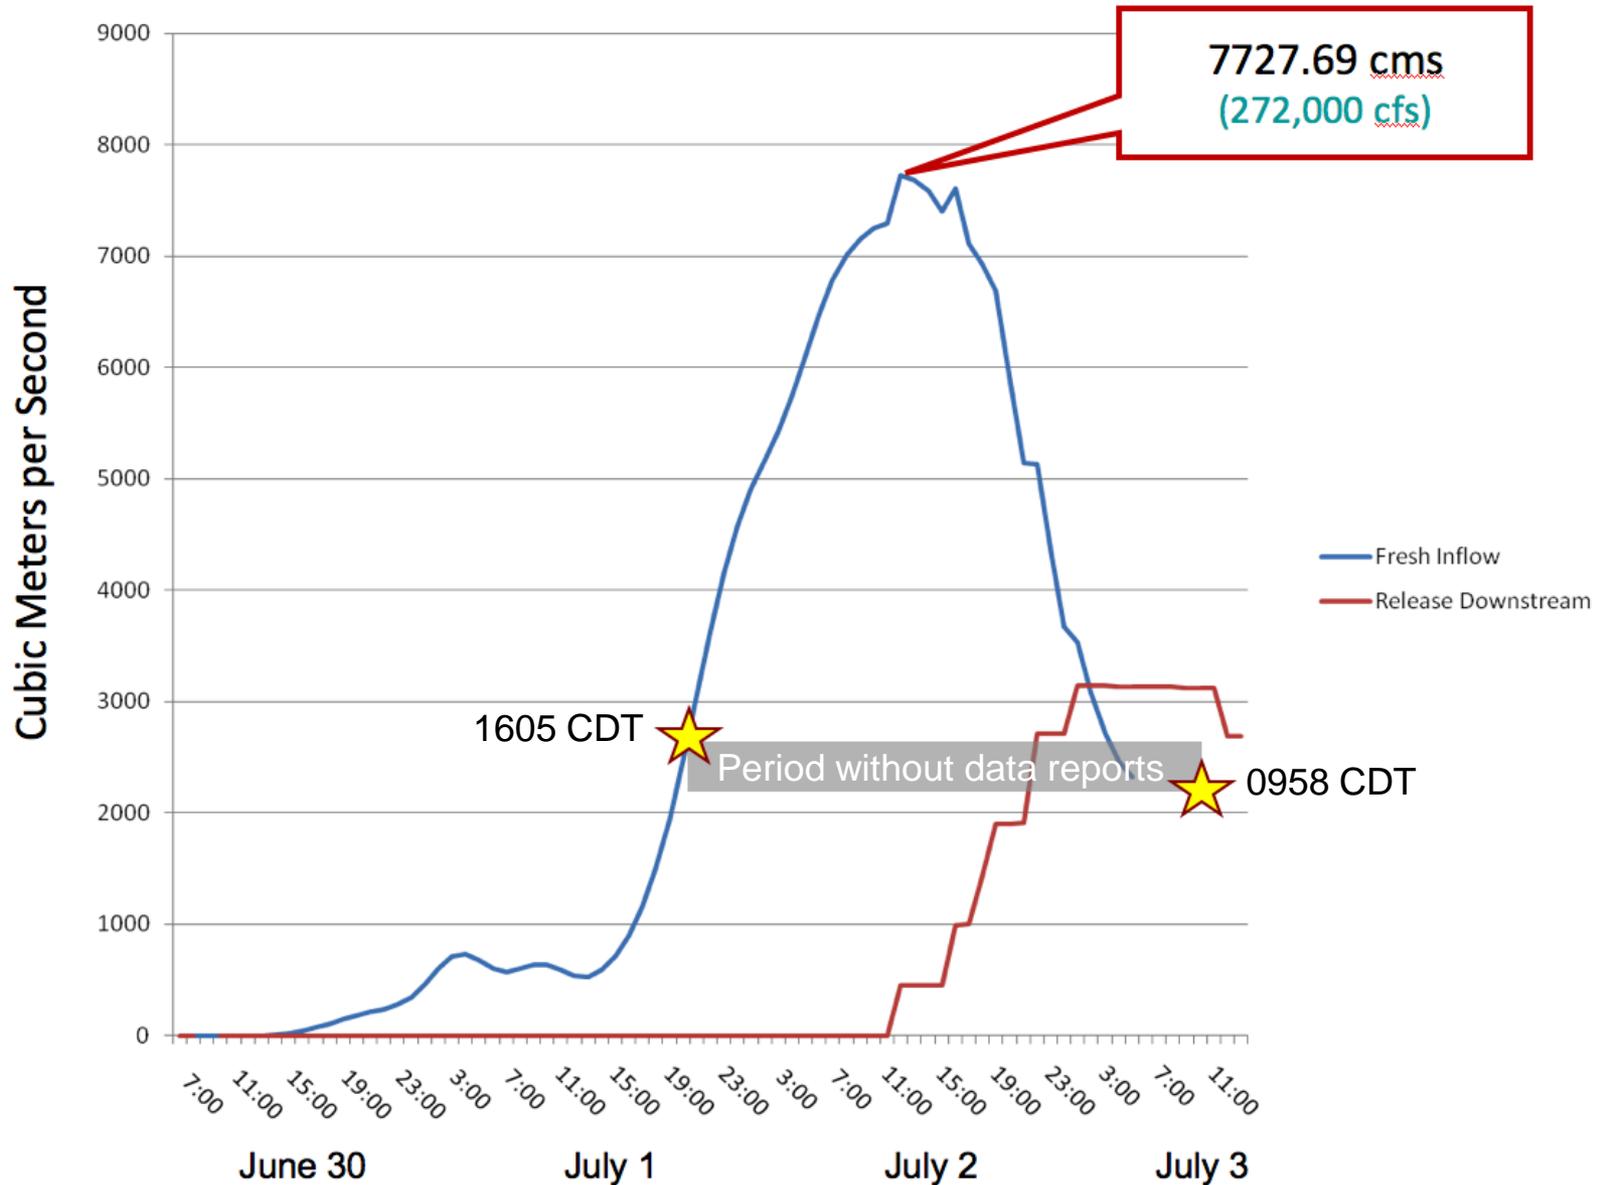
# El Cuchillo Reservoir, Nuevo Leon, Mexico

Exhibit 4: Official reports concerning the floodwaters entering and exiting the El Cuchillo Reservoir on the Rio San Juan in Nuevo Leon were not received for many hours during a critical phase after the landfall of Hurricane Alex. The delay introduced high levels of uncertainty into the flood modeling developed by the West Gulf River Forecast Center and other modeling efforts.

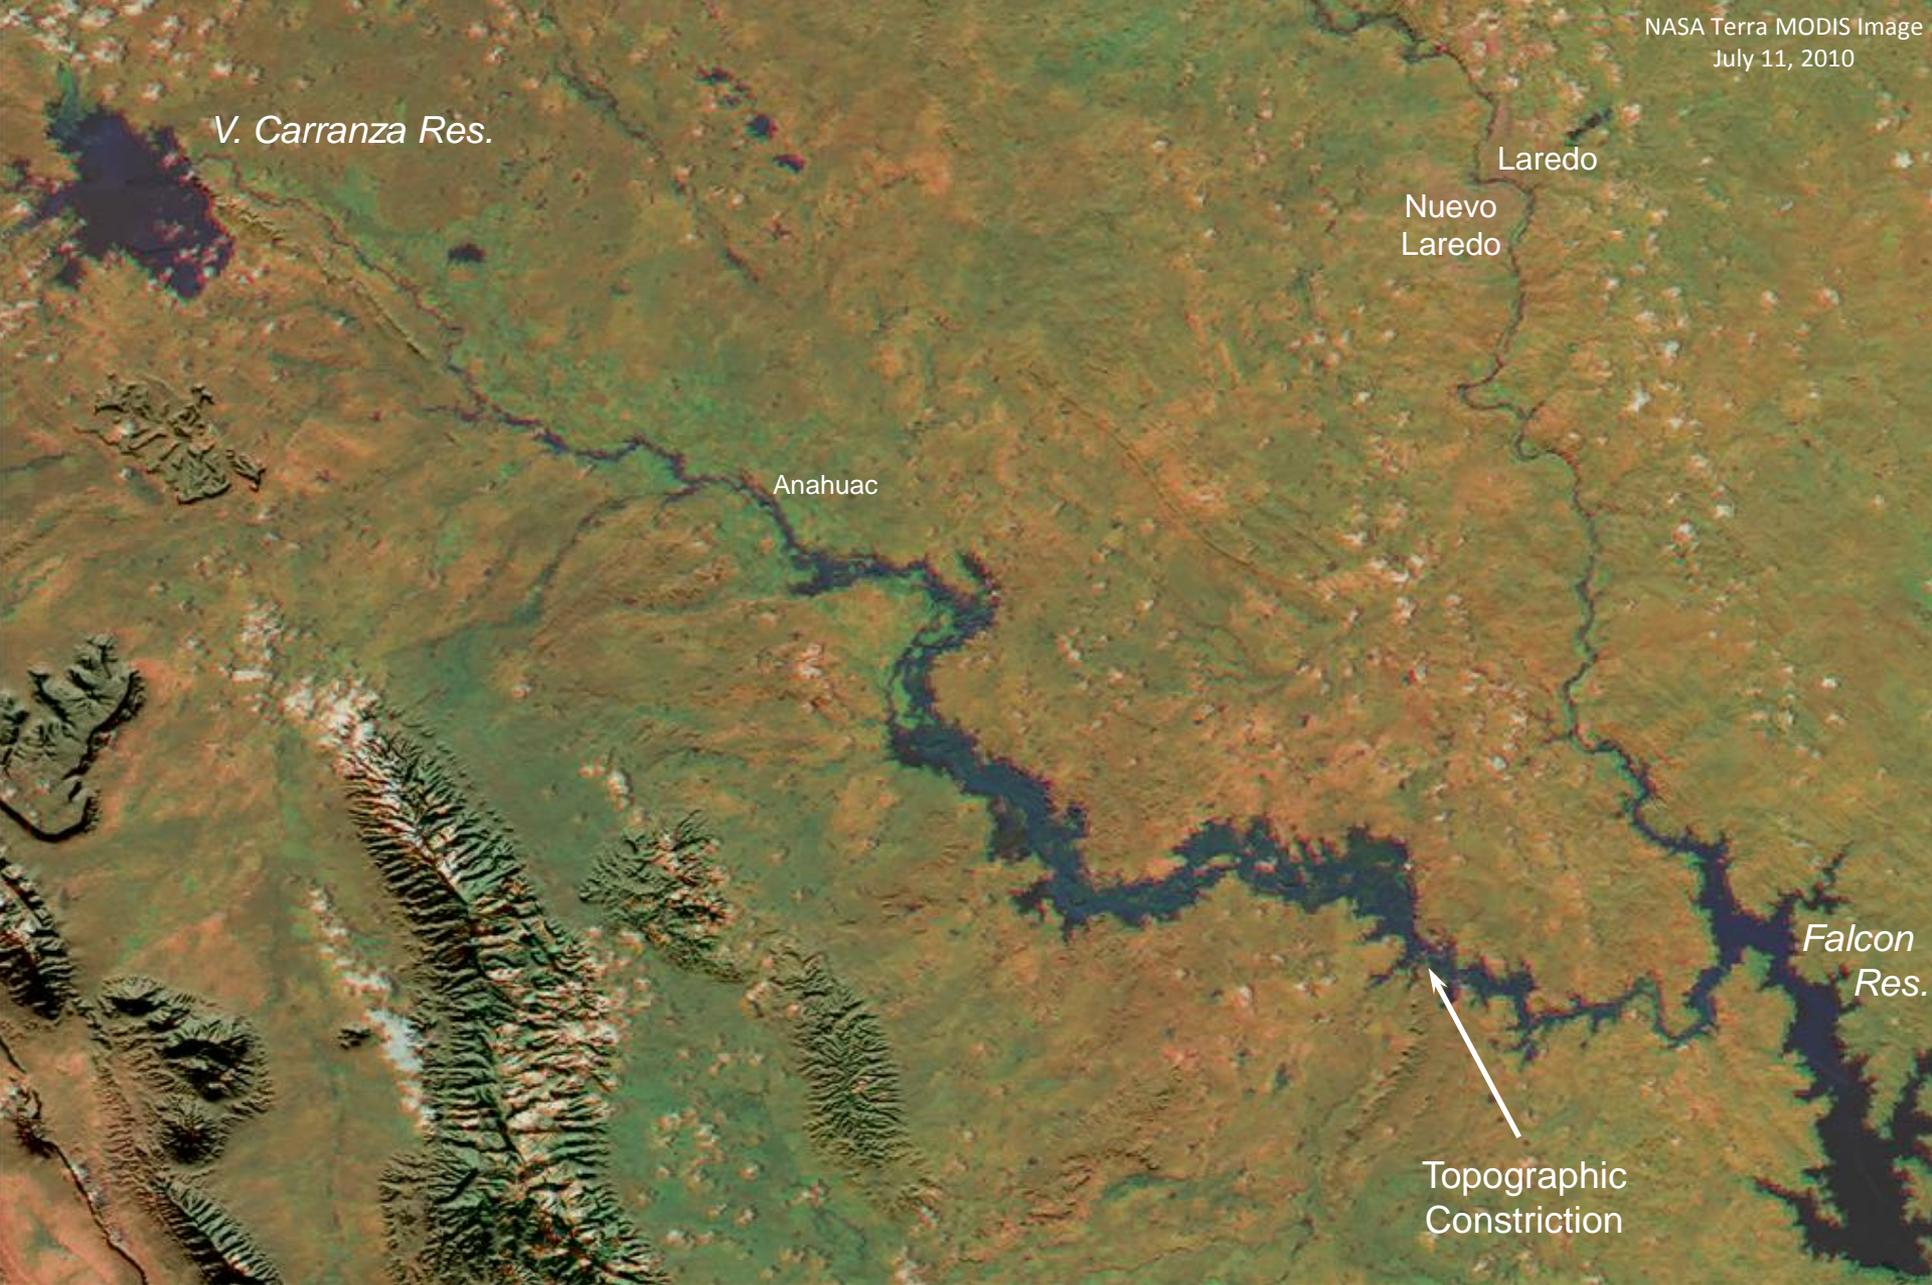
Exhibit 5: Floodwaters on the Rio Salado following Hurricane Alex were impounded behind a topographic constriction to create a temporary lake with a surface area comparable to the size of Falcon Reservoir. Formation of the lake delayed the arrival of the Rio Salado flood wave entering Falcon Reservoir and prevented more extensive flooding in the Lower Rio Grande Valley.

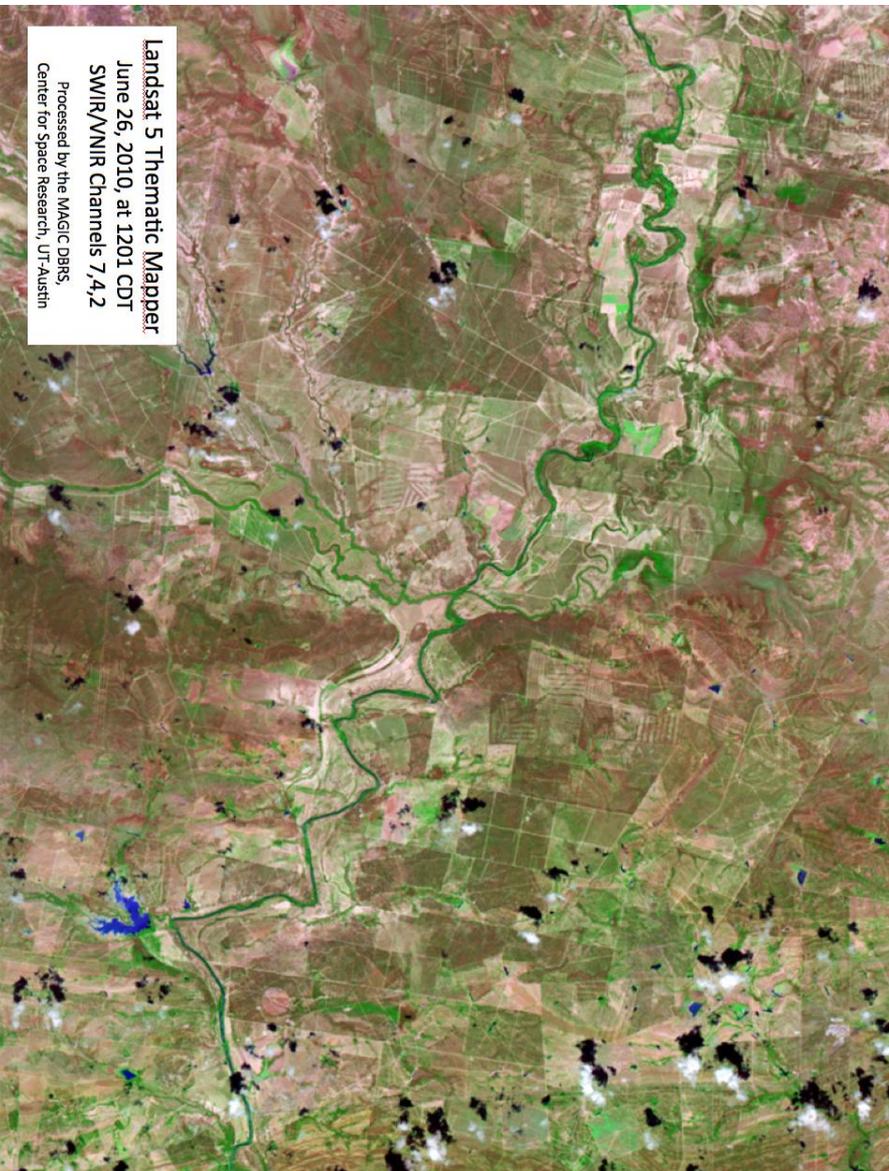
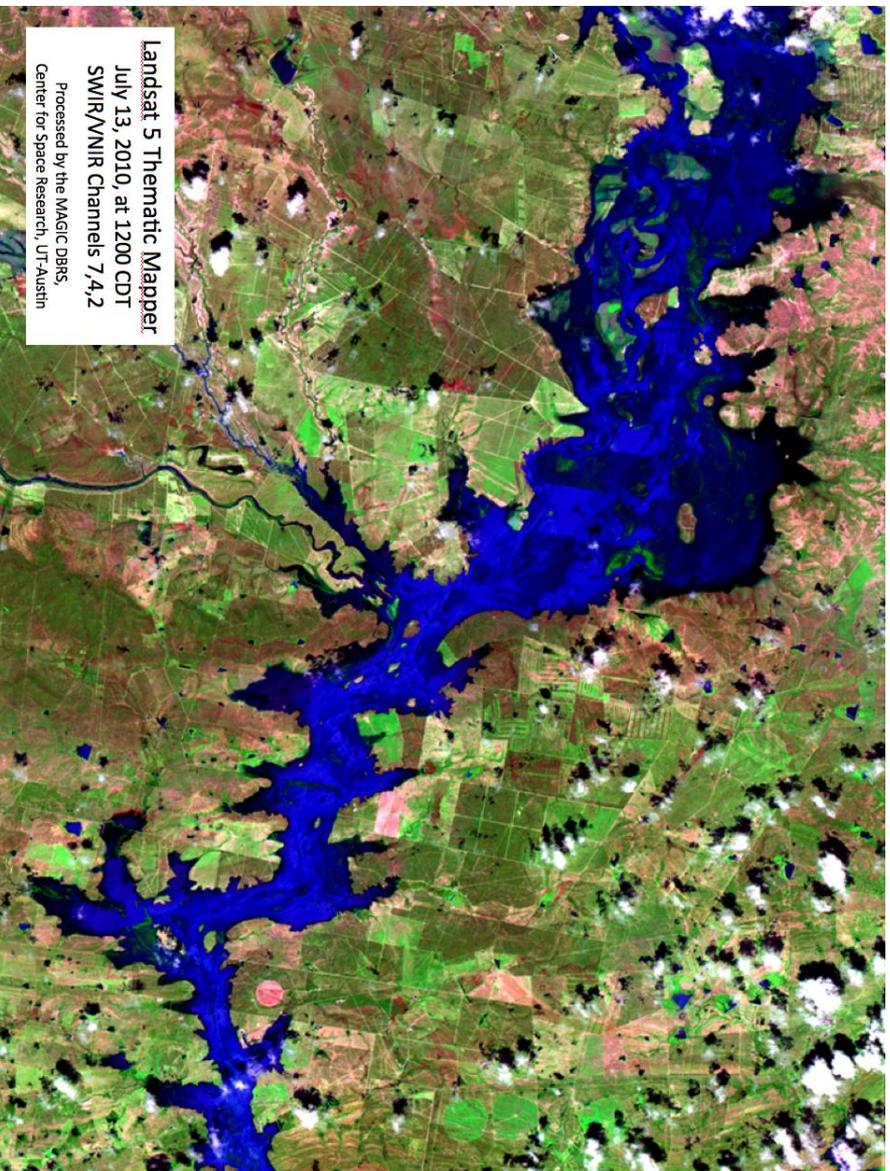
Exhibit 6: Two satellite images of the same area taken before Hurricane Alex on June 26 and after the storm on July 13 show the colossal flood along the lower reach of the Rio Salado upstream from Falcon Reservoir in Tamaulipas.

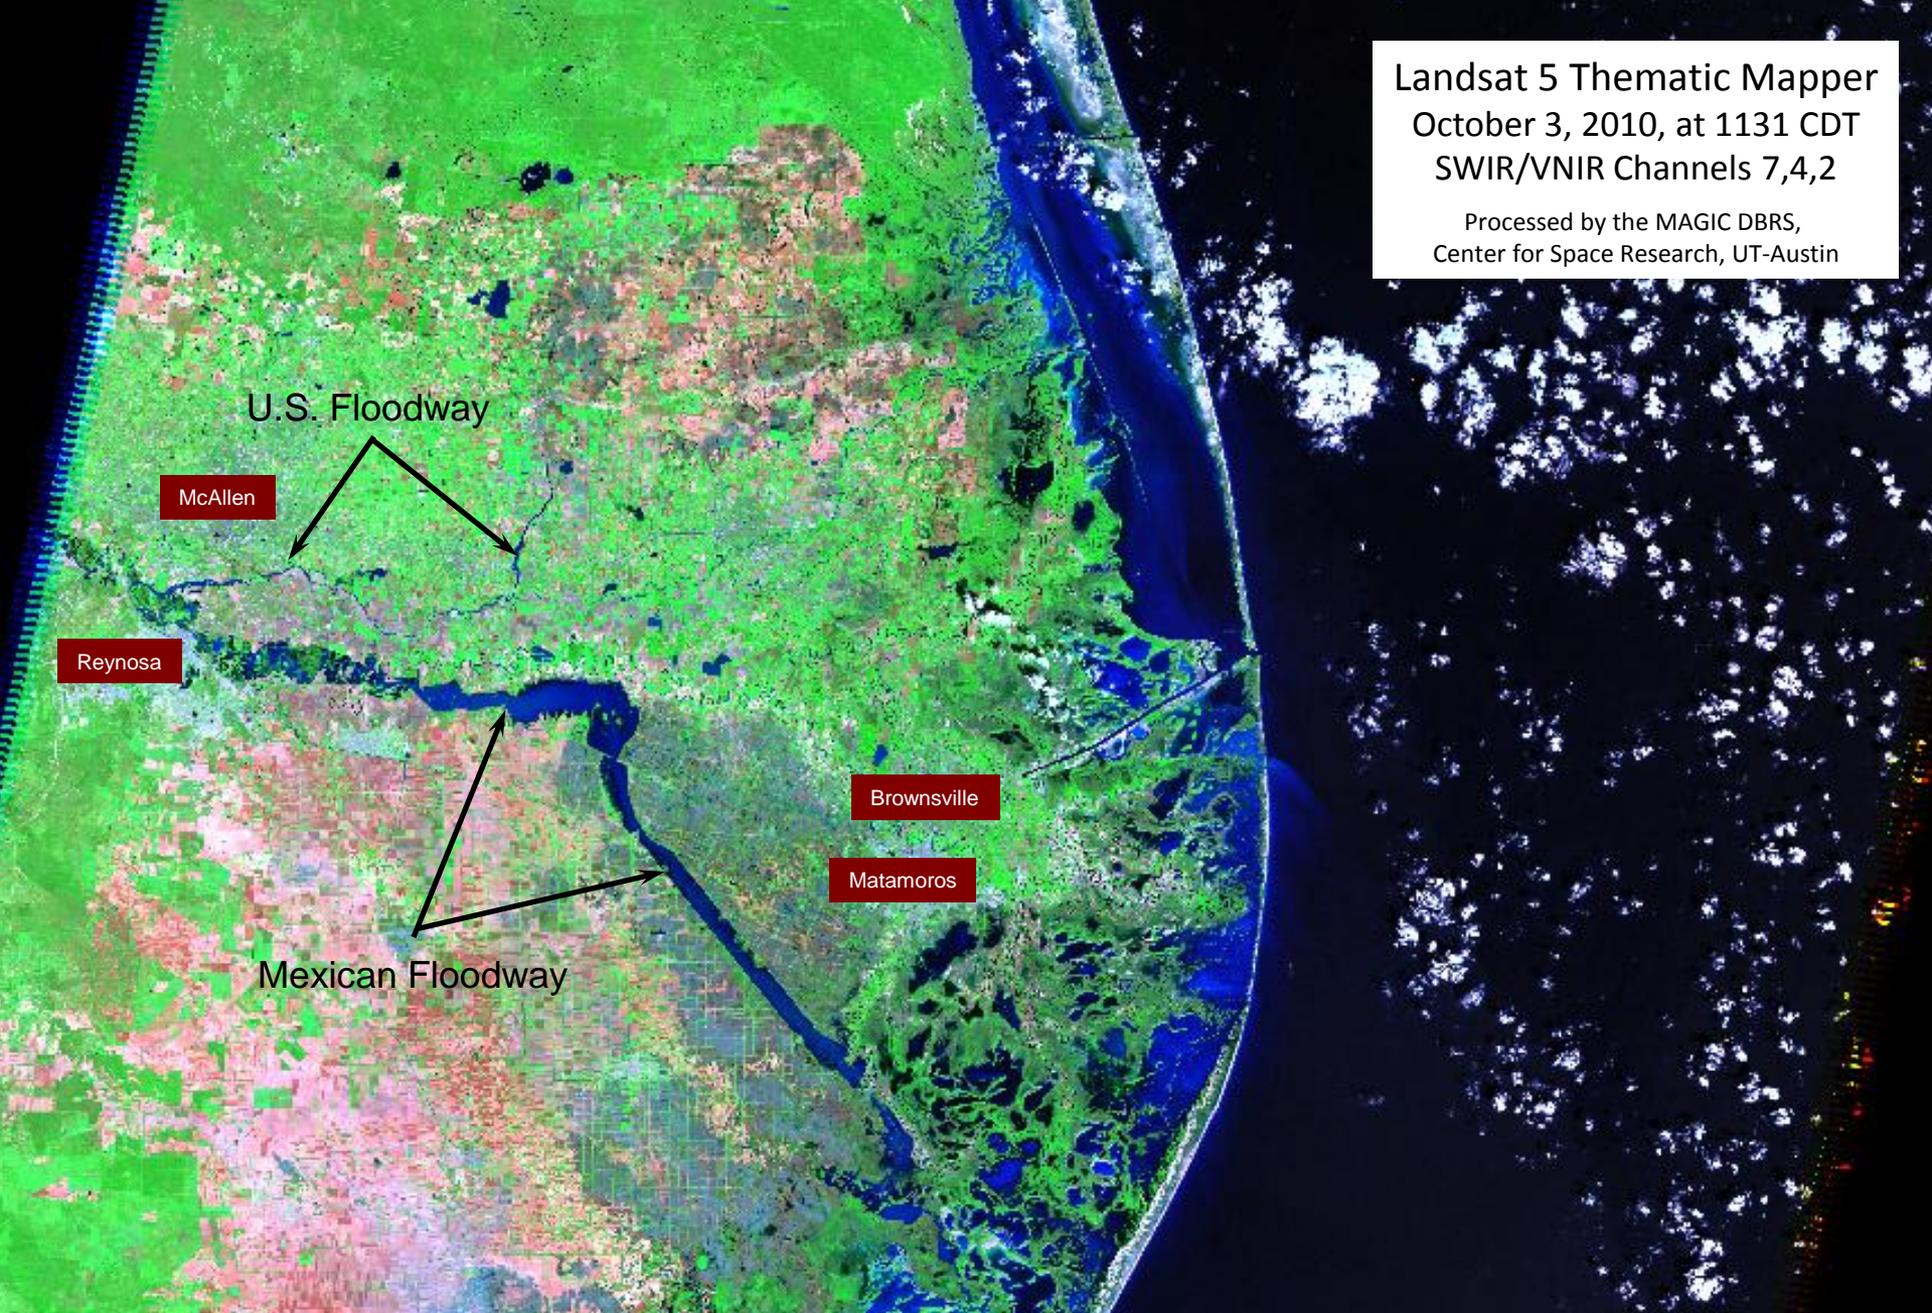
Landsat 5 Thematic Mapper  
October 3, 2010, at 1131 CDT  
SWIR/VNIR Channels 7,4,2

Exhibit 7: More than three months after Hurricane Alex, floodwaters remain visible in the interior floodways of the Lower Rio Grande Flood Control Project in Tamaulipas and Texas.
